OPERATION CASTLE

Project 3.5

BLAST EFFECTS ON MISCELLANEOUS STRUCTURES

REPORT TO THE SCIENTIFIC DIRECTOR

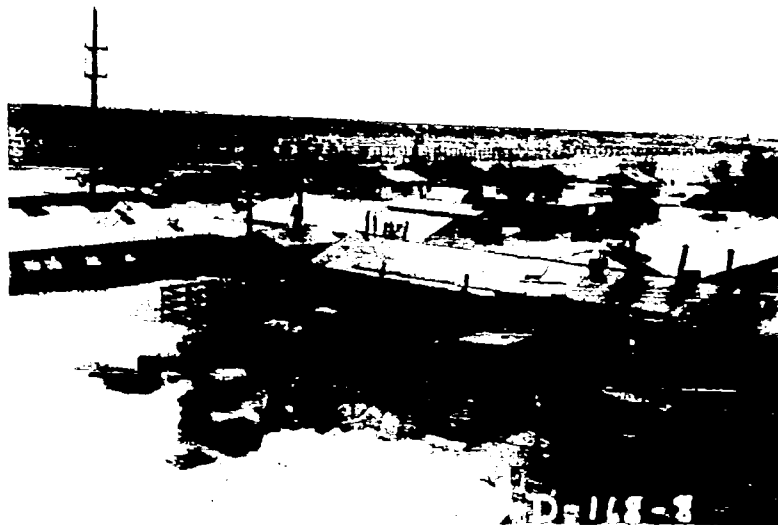
Figures 3.12 and 3.13 are pre- and postshot views of the north dining wing of the mess hall which most nearly faced ground zero. Most of the side was caved in and the rafters were badly damaged. Figures 3.14 and 3.15 are pre- and postshot views of the south dining wing. The entire side and large sections of the roof were blown out. One 16' x 40' section of roof was hurled a distance of 75 feet from its original location. Other views of interest are Figs. 3.2 and 3.16 - 3.19.

Fig. 3.19 Mess Hall, Administrative, and Living Areas, Tare Island, Postshot, 14-3/4 Miles from GZ

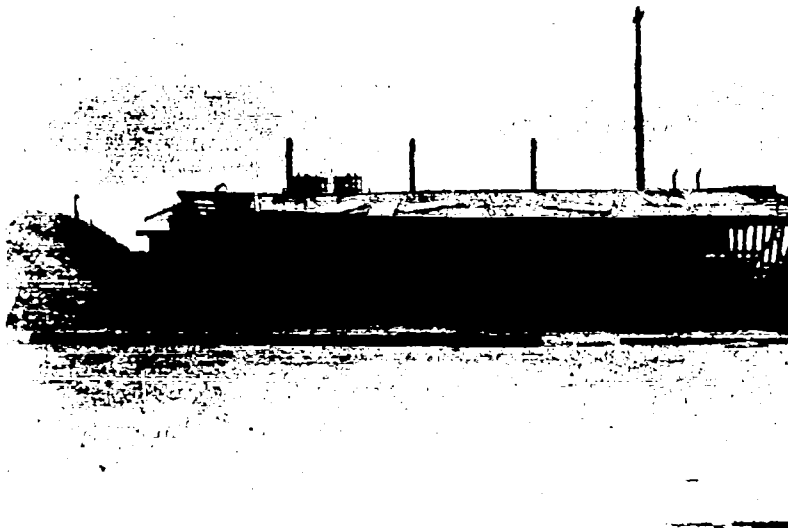
Figures 3.20 and 3.21 are pre- and postshot views of the scientific generator station looking east. Some of the rafters were broken, some sheet metal was ripped off the roof, and most of the plywood siding on the end of the building away from ground zero was blown off. Figure 3.22 is the end of this same building facing away from ground zero.

Fig. 3.21 Scientific Power House, Tare Island, Postshot,
14-3/4 Miles from GZ

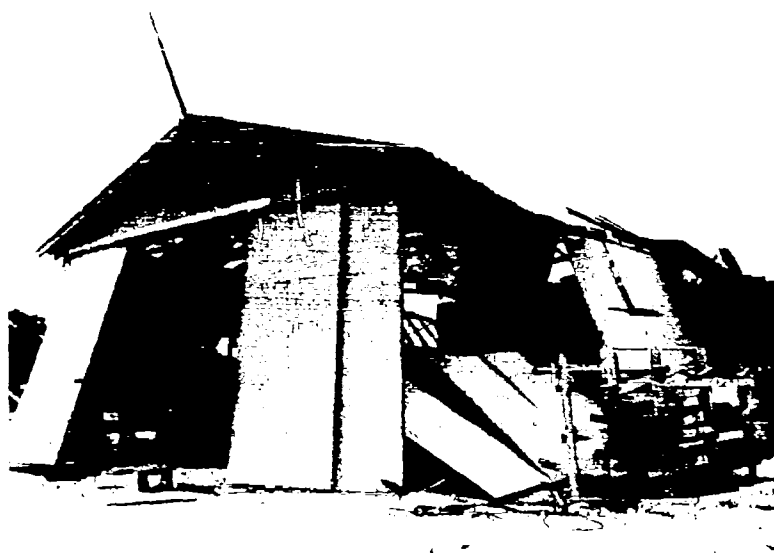
All the warehouses on Tare Island suffered severe damage. However, the shop buildings (Bldgs 19 and 20, Fig. 2.1) came through the blast with light damage even though the design of these buildings was similar. This is seen best by studying Fig. 3.1. No explanation is offered for this marked difference in degree of damage to similar structures in the same area. Figures 3.23 - 3.25 are views of the Holmes and Narver bin storage warehouse. Figures 3.26 - 3.28 show different views of the

Fig. 3.24 Bin Storage Warehouse Looking Southwest, Tare Island,
Postshot, 14-3/4 Miles from GZ

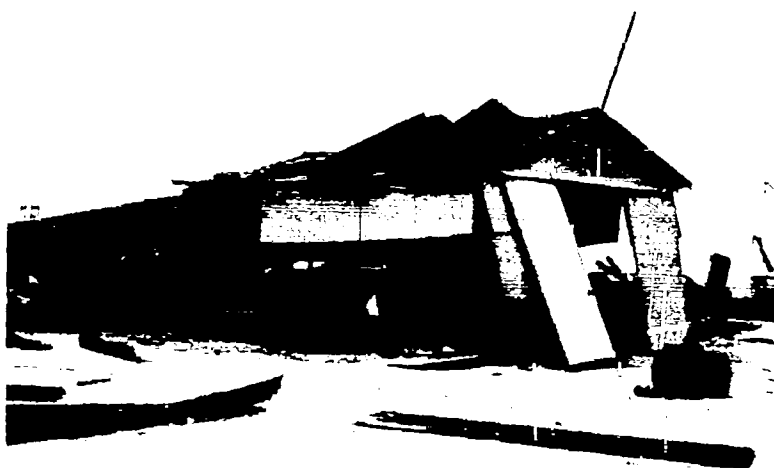
Fig. 3.25 Bin Storage Warehouse Looking Northwest, Tare Island,
Postshot, 14-3/4 Miles from GZ

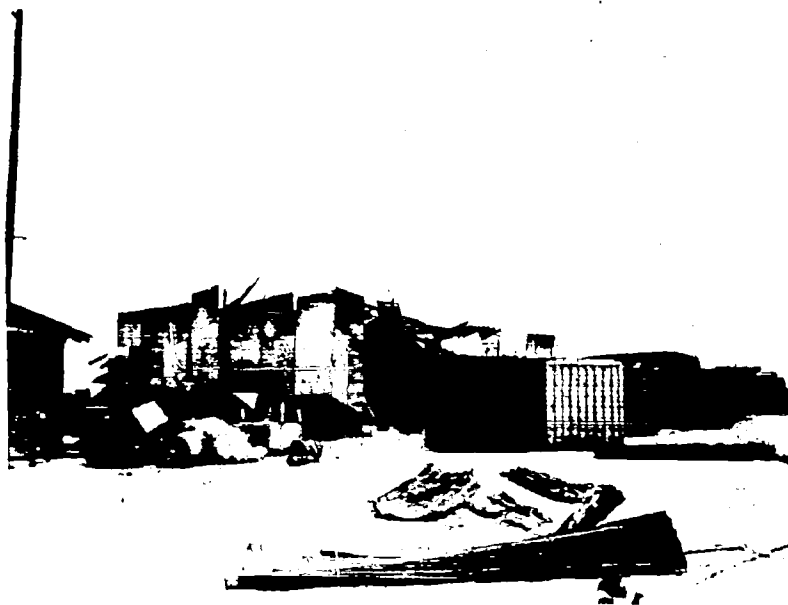
Fig. 3.28 Bulk Storage Warehouse from Northwest, Tare Island,
Postshot, 14-3/4 Miles from GZ

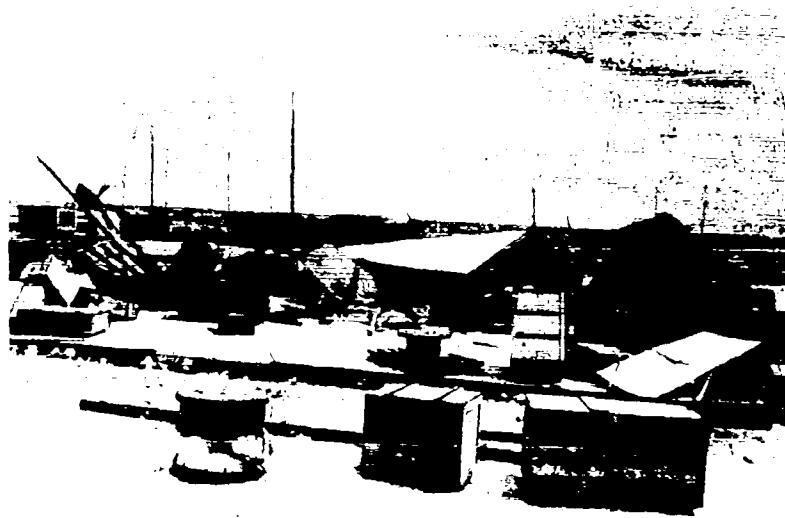
Fig. 3.29 Another Bulk Storage Warehouse, Tare Island, Viewed from
Direction of Burst, 14-3/4 Miles from GZ

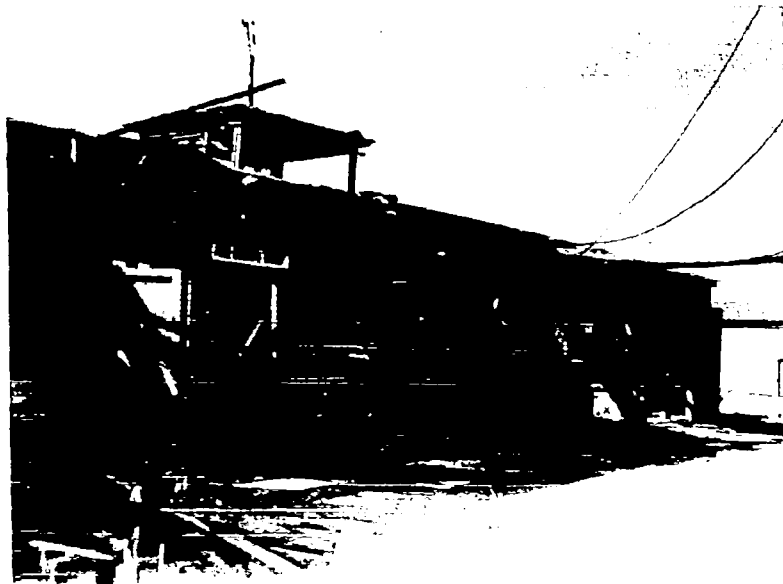
Figure 3.30 is a view of the front side of the Air Operations building of the airport facility on Peter Island. It is noted that the side has been caved in, the studs being broken near their center except at the corners of the building and door frames. The 2" x 8" rafters were broken near the center of their span. Also, about one-half of the sheet metal roofing had been blown off as shown in Fig. 3.31. Most of the sash had been removed from the control tower before the burst. The glass which was left in place was not damaged.

Fig. 3.30 Air Operations and Control Tower, Peter Island,
Postshot, 15-1/2 Miles from GZ

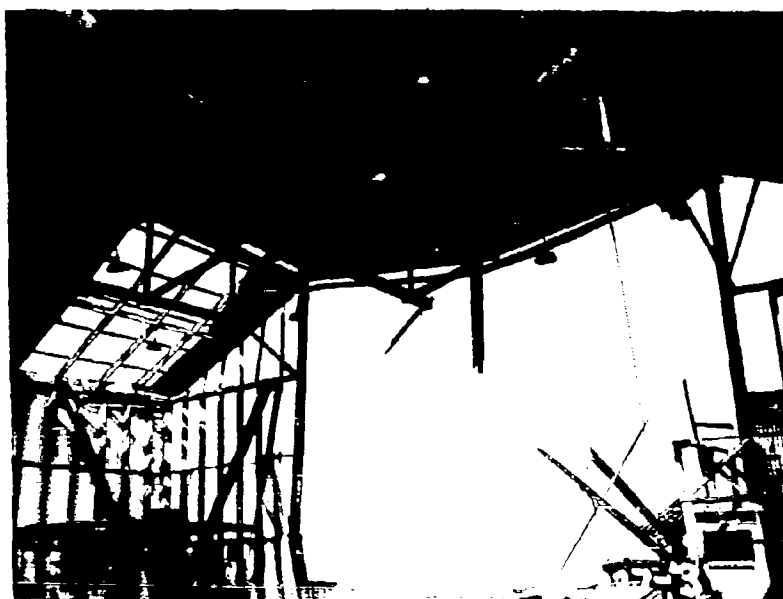
This structure suffered moderate to severe damage. The northwest (back) end of the hangar, including the 75-foot truss, had been almost completely blown out. This is best illustrated in Figs. 3.32 - 3.35. The lower chord of the 75-foot truss on the southeast (front) end was deflected outward several inches at the center of the span. Also, a considerable number of the 2" x 10" rafters were broken by the blast.

Fig. 3.32 Hangar Building Looking Northwest, Peter Island,
Postshot, 15-1/2 Miles from GZ

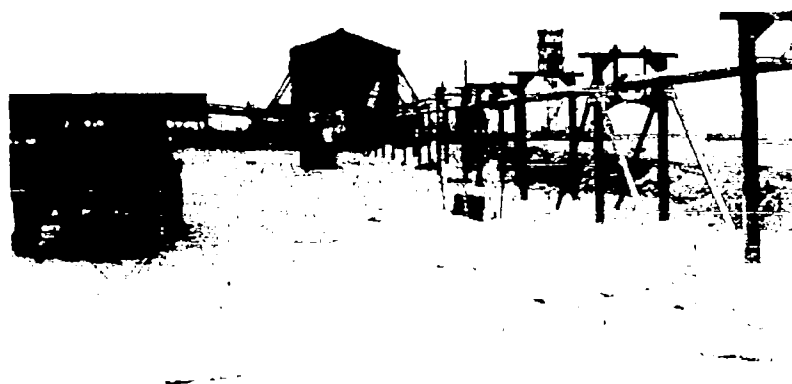
The steel photographic tower received no damage from the blast. The aluminum sheet metal siding on the steel frame building (Station 50) was dished inward on the west end and blown off on the east end. Figures 3.36 - 3.38 illustrate this damage. The sheet metal had been removed from the north side prior to shot time for Shot 1.

Fig. 3.38 Station 50 Looking West, Tare Island, Postshot,
14-3/4 Miles from GZ

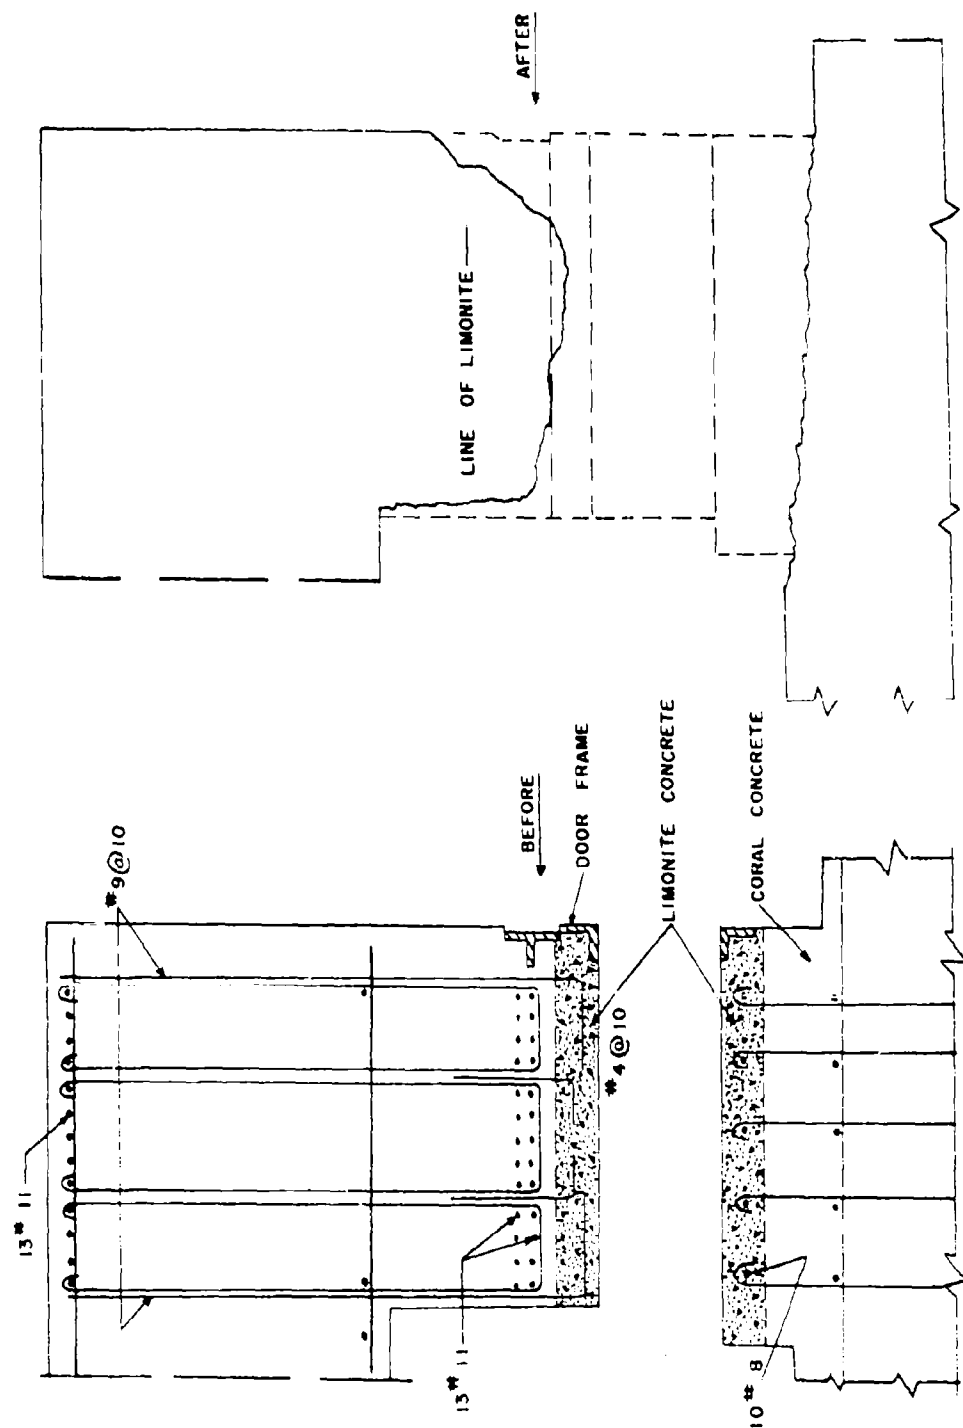
The front and side walls above the third floor received severe damage from the blast. Figures 3.39 and 3.40 show two views of the front wall above the third floor. Figure 3.41 indicates the design of this wall and shows the location of the reinforcing steel around the shutter door frame. This figure also shows the approximate failure surface of this wall. A tension failure due to bending of the wall above the opening can be seen in Fig. 3.40. Figure 3.42 is a schematic showing positions of the shutter door before and after failure. It could not be determined definitely that the shutter door was in position No. 2, as shown in Fig. 3.42, at the time of arrival of the blast wave. Several times during testing operations this door failed to latch shut when released. Figures 3.43 and 3.44 show primary shear cracks in the side walls adjacent to the shutter door opening.

Fig. 3.41 Station 1341, Able Island, Front Wall-Third Floor, Vertical Section, 7500 ft from GZ

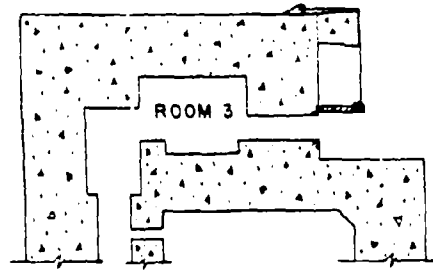
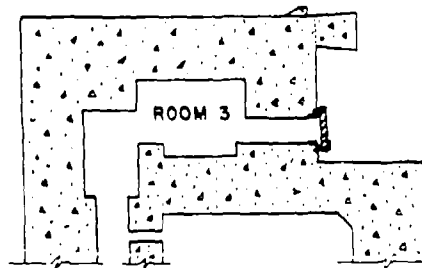
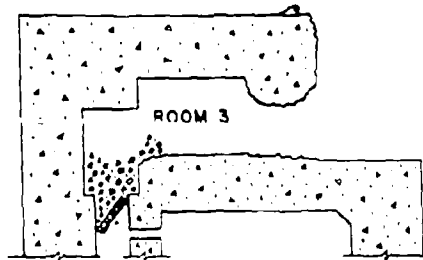
Fig. 3.42 Position of Shutter Door, Station 1341, Able Island,
7500 ft from GZ

Due to the failure of the wall supporting the shutter door, the blast wave entered the building. The shutter door was hurled inward and dropped part way down the chimney, lodging in a position No. 3 as shown in Fig. 3.42. The forces from the blast also broke the latches and hinges from three other doors, namely, the lead door entering the equipment room on the first floor, the light weight steel door between rooms No. 1 and No. 4 on the first floor, and the main personnel door on the second floor. This door is shown in Fig. 3.45. The following doors did not fail: two exterior lead doors on the side of room No. 4, and three steel doors on the outside of the back wall of the equipment room.

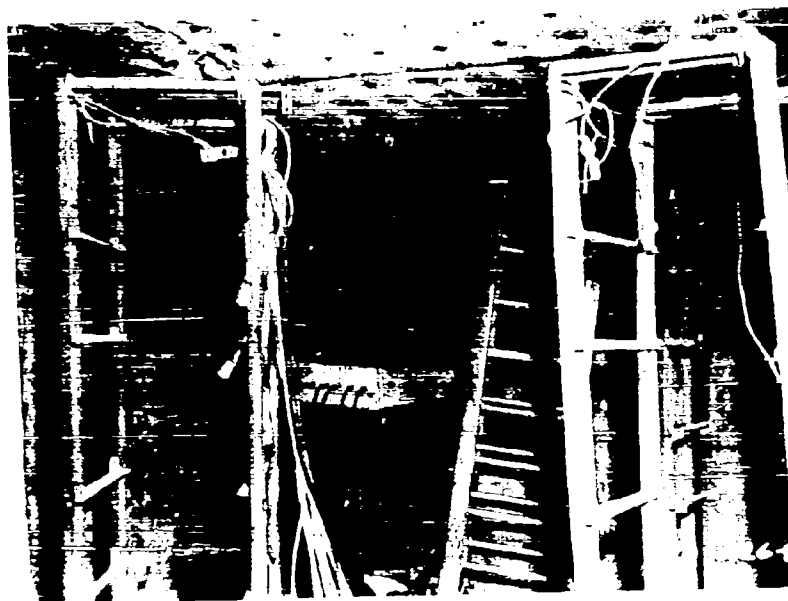
(3) The scientific equipment, equipment racks, and other interior structures were severely damaged. This damage can be noted in Figs. 3.48 and 3.51.

Fig. 3.48 Interior I - Room No. 3, Station 1341, Able Island,
Postshot, 7500 ft from GZ

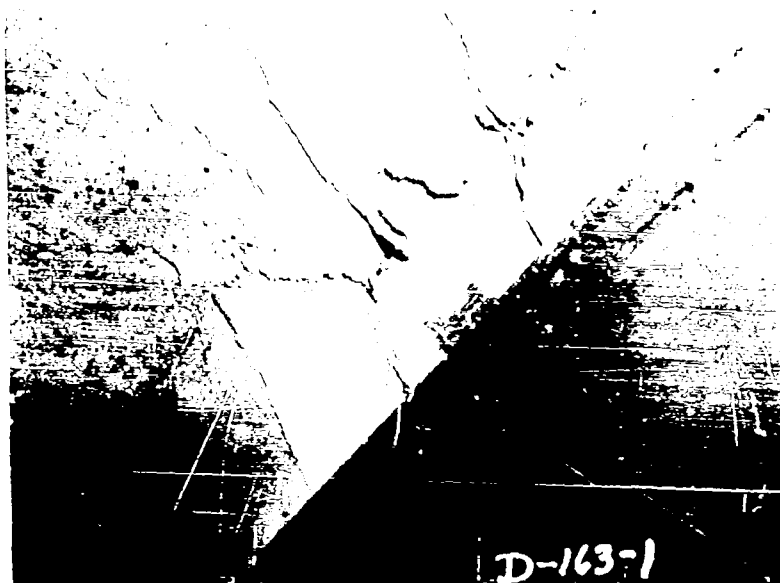
Fig. 3.56 Station 1200, Wall and Ceiling, Position (3) as Shown in Fig. 2.7, Charlie Island, Postshot, 7565 ft from GZ
